# Site Report: J Cove

*Original restoration completed in 2010*

Report Credit: Davis, J., LeClaire, A., Bost, M., Walker, Q., & Giannelli, R. (2024). Site Report: J Cove. US DOC NOAA NOS National Centers for Coastal Ocean Science (NCCOS). Marsh Mounds:

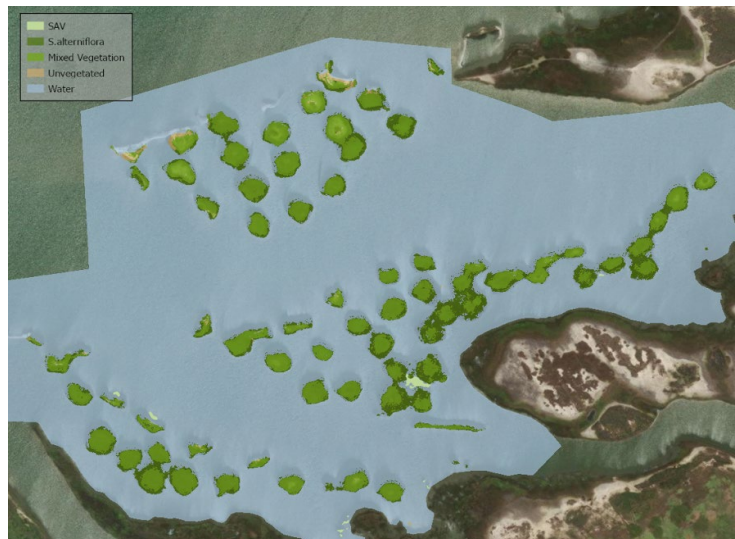
**Figure 5.** Distribution of dominant vegetated habitats as of October 2023 based on analysis of drone-collected imagery

As of 2023, J Cove marsh mounds were characterized by a dense ring of monospecific *Spartina alterniflora* at lower elevations (upper extent of monospecific *S. alterniflora* growth ~ 0.4 m [1.3 ft] NAVD88). At higher elevations, the vegetative cover transitioned to a mixed community of short-form *S. alterniflora*, *Salicornia* sp. and *Batis maritima*. Several small patches of SAV were identified from aerial imagery (0.15 acres in total; Figure 5). This is likely a conservative estimate of the total SAV present due to water clarity limitations during image collection. The SAV is presumed to be *Halodule wrightii* based on positive confirmation of a patch with similar spectral characteristics at a nearby site.

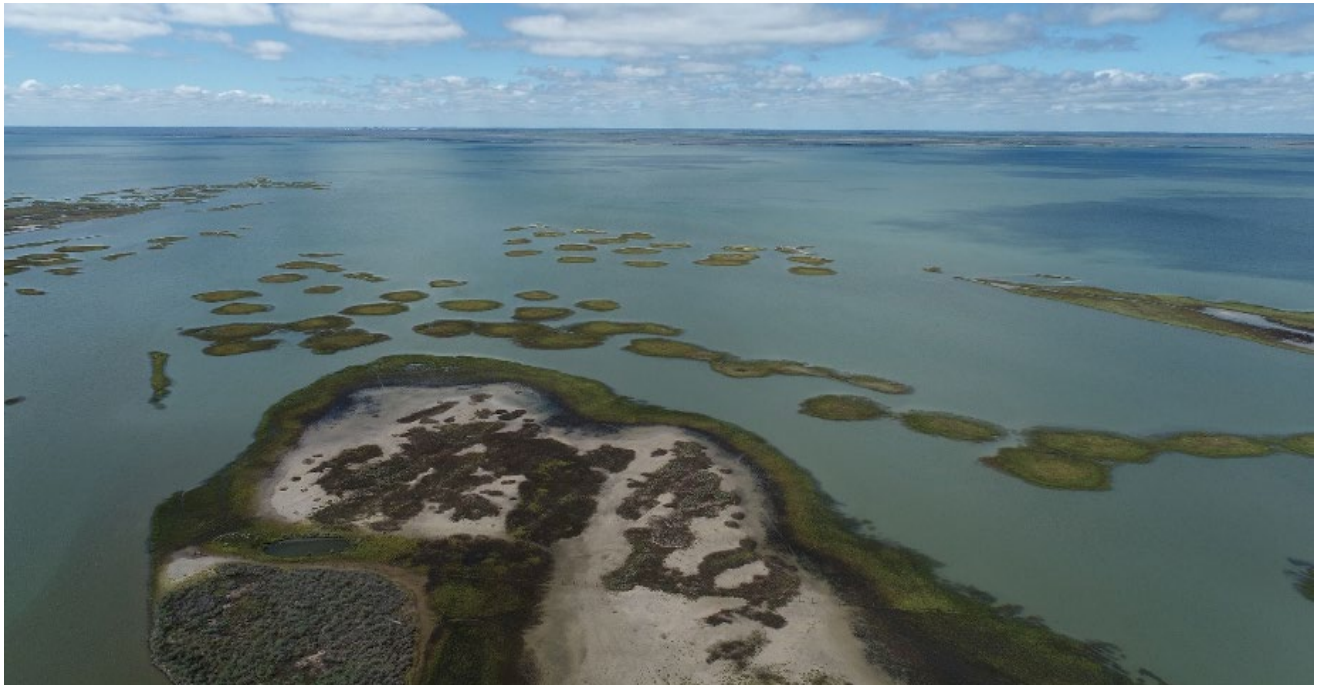
As of October 2023 (13 years after project completion), 60% of the created intertidal habitat is still present. The majority of the loss has been from erosion of the outer perimeter mounds which were designed to provide a temporary wave break, allowing the vegetation on the interior mounds to become fully established. This strategy appears to have been largely successful based on the persistence and dense vegetative cover of the interior mounds. Further, it seems likely that erosion of the perimeter mounds served as a source of material for the interior mounds. Although the mounds do not appear to be building elevation fast enough to keep pace with local relative sea level rise, they have been effective at providing intertidal marsh habitat and buffering the remaining natural shoreline marsh from waves.
